## Proactive Transmission Belt Replacement

This document describes a recently-discovered issue with the transmission belt between the main belt section and the alignment section on the iJetColor 1175P, as well as steps to remediate the issue.

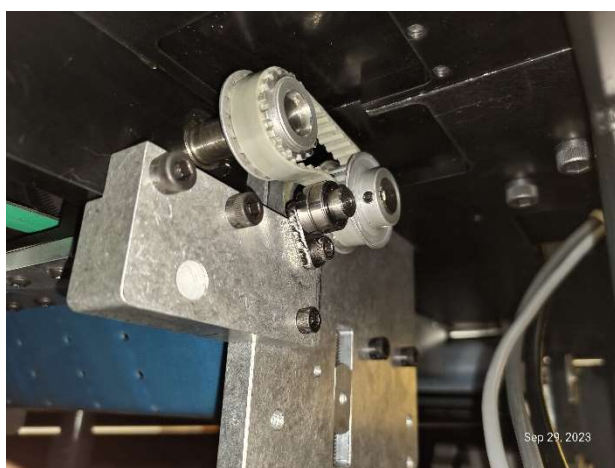
This Technical Bulletin applies only if you have the gray variant of the transmission belt, as shown below. The gray belt was used on 1175P units produced between July 2022 and March 2023.

*Figure 1: The gray transmission belt, in situ.*

It has been observed recently that these gray belts have begun to fail. As this transmission belt is expected to last the life of the product, Printware is offering to replace the gray belts, under warranty, with an upgraded black variant. If you have one of these gray belts, please contact Support, and they will send you a new belt at no charge. We have prepared a detailed video guide on the replacement process, which can be found on the iJetColor Wizard, or at the link below.

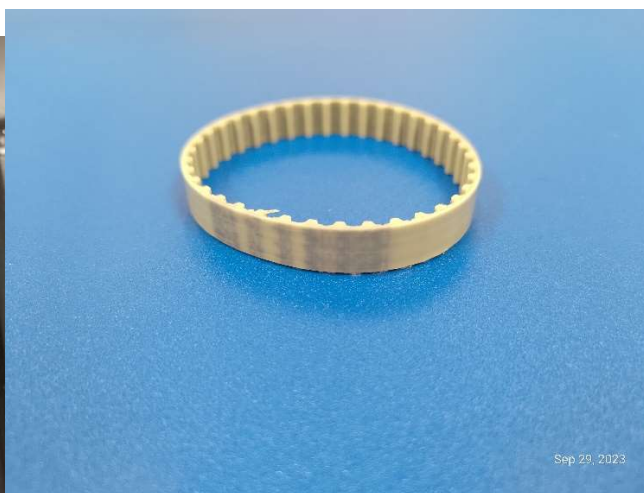
*Figure 2: The gray transmission belt, ex situ.*
